RE-70-196

**EROSION IN 7.62MM MACHINE GUN BARRELS**

**TECHNICAL REPORT**

**U. S. ARMY WEAPONS COMMAND**

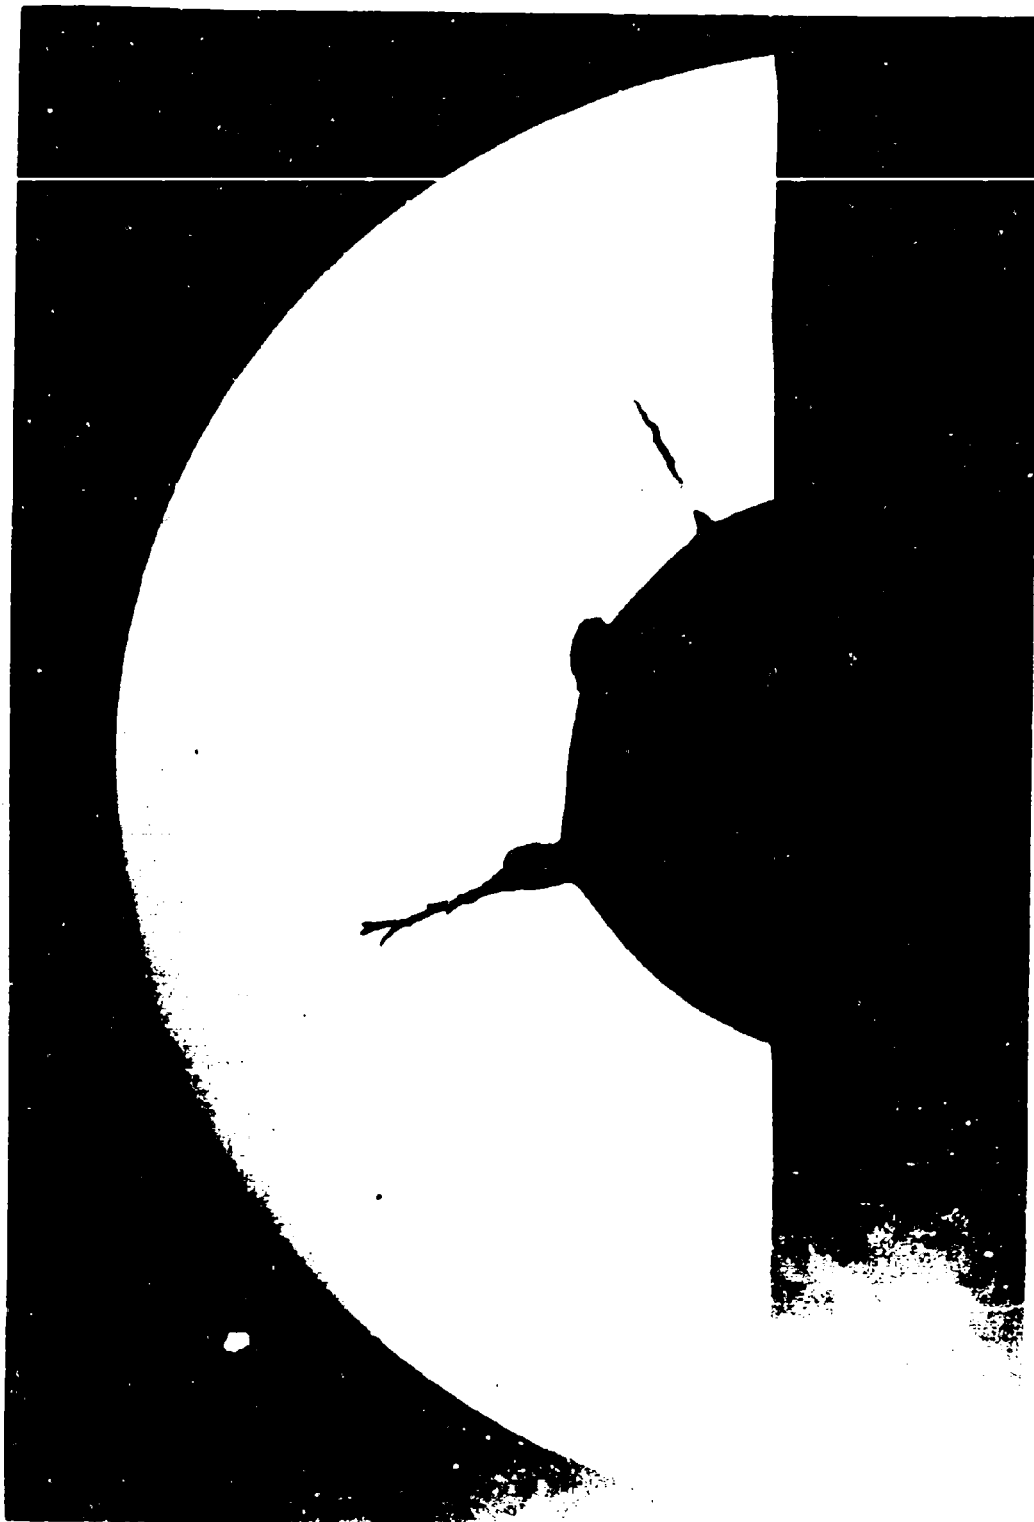
The advanced stages of erosion introduce areas near the breech that are particularly susceptible to catastrophic failure. A cross section of such an area is shown in Figure 1. This segment was taken from a barrel that had actually failed at the breech end, causing the damage shown in Figure 2. Failures of this type not only completely render the weapon useless but also may be fatal to personnel in the vicinity of the weapon.

FIGURE 1    TRANSVERSE SECTION OF FAILED BARREL NEAR THE BREECH END

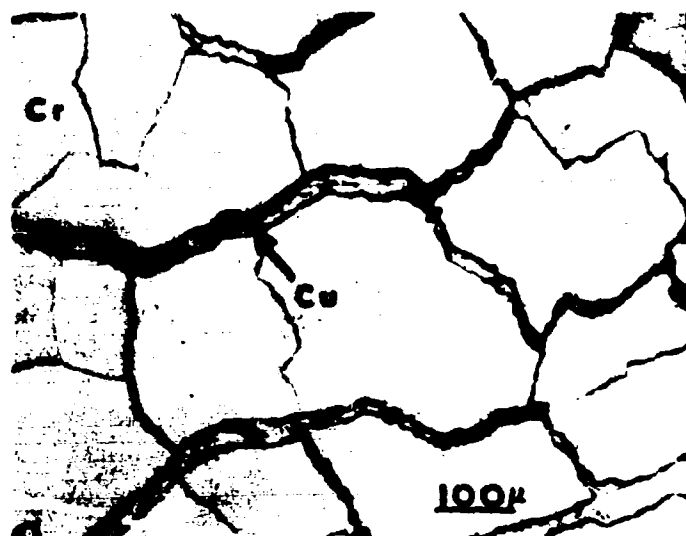
barrel. The extent of copper extrusion into the cracks is better observed in the polished section of Figure 4. The cracks observed on the bore surface extended through the chromium and well into the underlying steel, as shown in Figure 5. Not all of the cracks in the steel exhibited copper, but the microprobe analysis revealed copper in some of the most minute cracks (Figure 6). The cracks became larger primarily in the radial direction, with some bifurcation noted. An altered zone was observed to be associated with the cracks in the steel. Examples representative of the appearance of the altered zone are shown in Figures 7 and 8. The zone appears to consist of more than one phase and to have resisted chemical attack by common etchants (nital and picral) as depicted in Figure 9. Identification of this zone or of the phases present is not yet complete. However, it is generally described as being considerably harder than the unaffected steel. Microprobe analysis revealed that this zone is of a different chemical composition than that of the unaltered steel as evidenced by the scan shown in Figure 10.

FIGURE 4 COPPER FILLED CRACK NETWORK IN  
CHROMIUM PLATING  
(unetched)

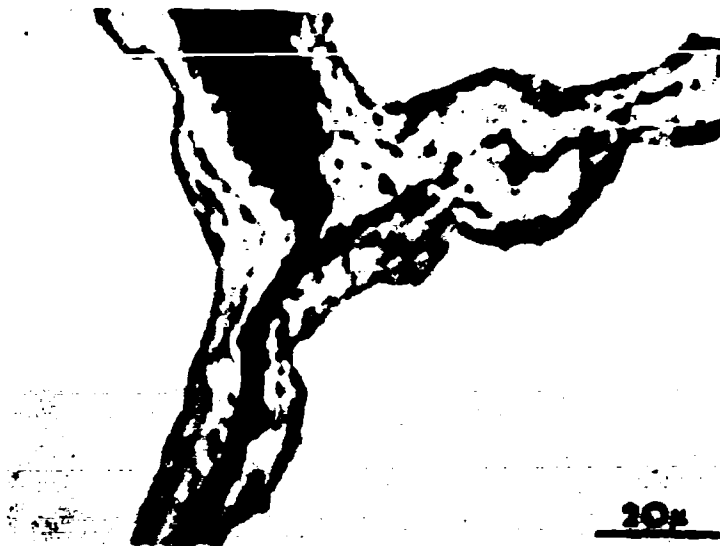
**FIGURE 7**

**OPTICAL PHOTOMICROGRAPH OF  
ALTERED ZONE SURROUNDING A CRACK**

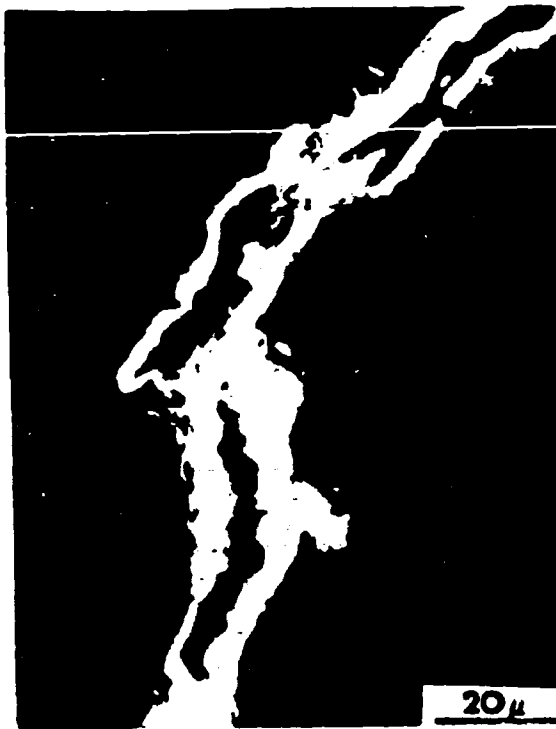
FIGURE 9 STRUCTURE OVERETCHED TO REVEAL ALTERED ZONE  
(etched in nital)

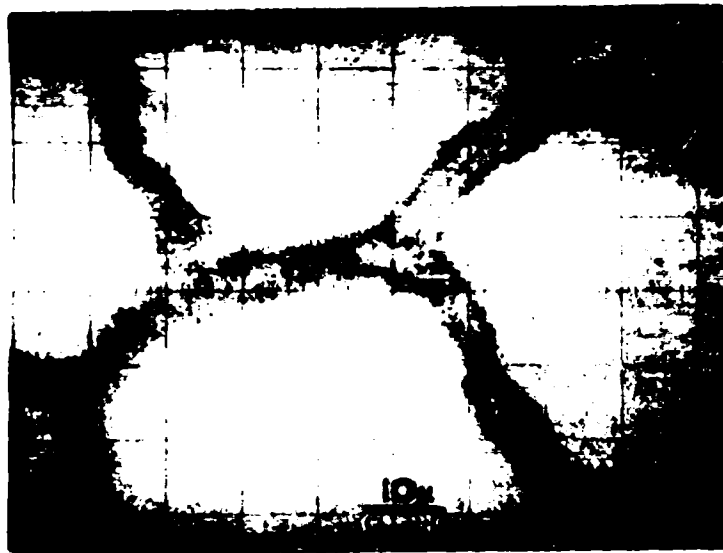
FIGURE 10 MICROPROBE ANALYSIS BY BACK-SCATTERED  
ELECTRONS TO DEFINE ALTERED ZONE

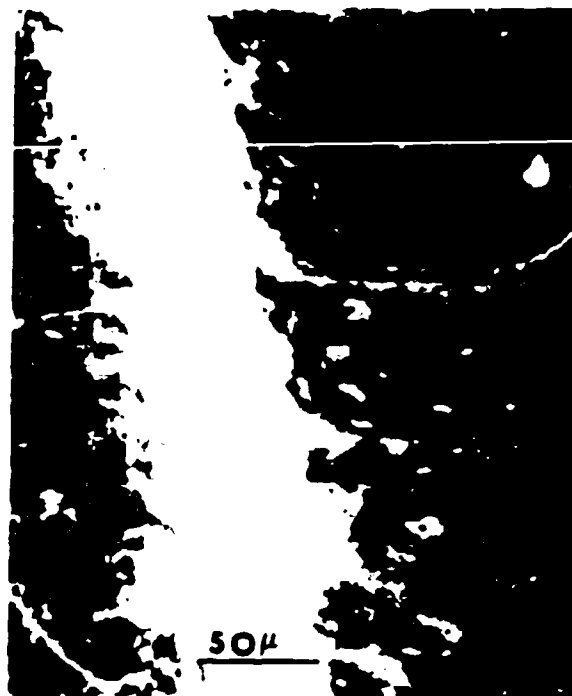
**FIGURE 11** SCANNING ELECTRON MICROGRAPH SHOWING  
COPPER COLLECTED INTO CRACKS AND CORNERS  
OF BORE SURFACE

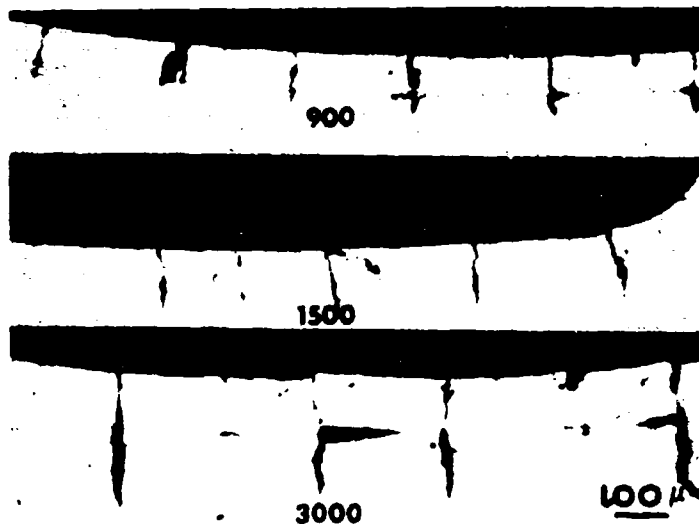
FIGURE 16 OPTICAL PHOTOMICROGRAPHS OF  
TRANSVERSE BARREL SECTIONS AFTER  
900, 1500, AND 3000 ROUNDS  
(unetched)

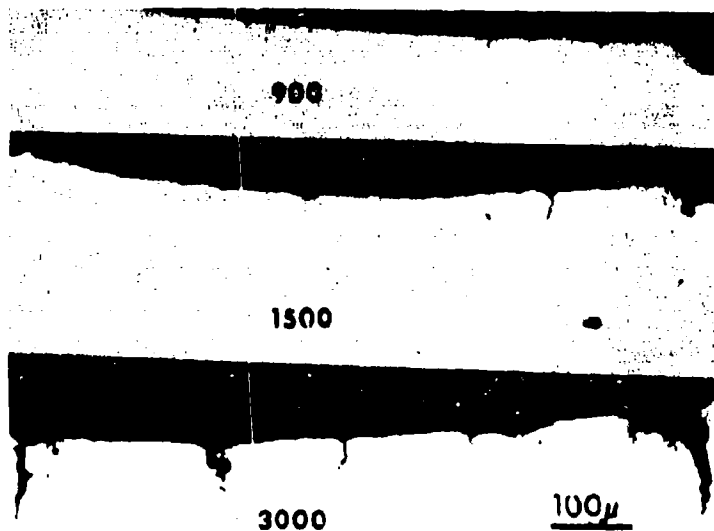
FIGURE 20

OPTICAL PHOTOMICROGRAPHS OF  
TRANSVERSE SECTIONS OF UNPLATED GUN BARRELS  
AFTER 900, 1500, AND 3000 ROUNDS  
(unetched)

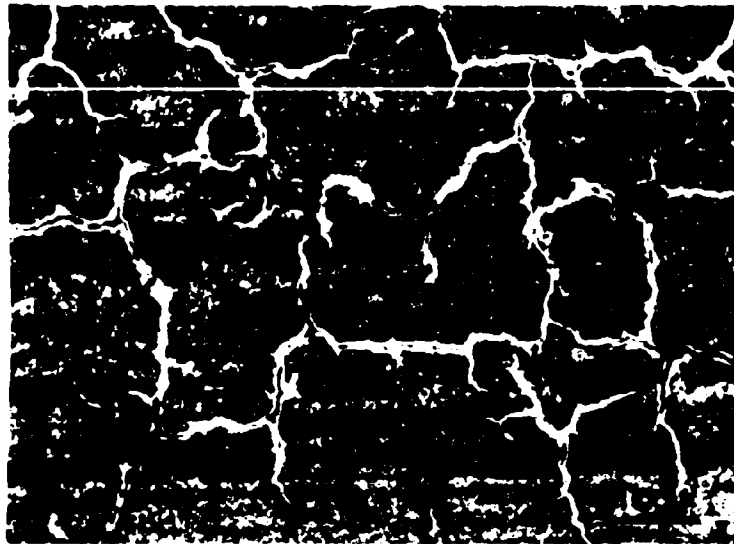
FIGURE 21      OPTICAL PHOTOMICROGRAPH SHOWING  
CRACK NETWORK BENEATH THE BORE  
OF UNPLATED STEEL AFTER 3000 ROUNDS  
(etched in nital)

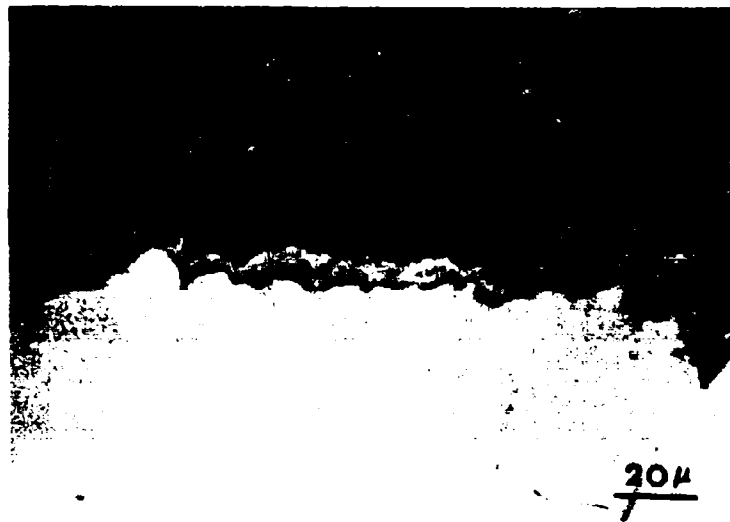
FIGURE 22      OPTICAL PHOTOMICROGRAPH OF  
ALTERED ZONE FORMED ON BORE SURFACE  
OF UNPLATED BARREL AFTER 900 ROUNDS
